Rockbox | CastoChrome®

The Challenge

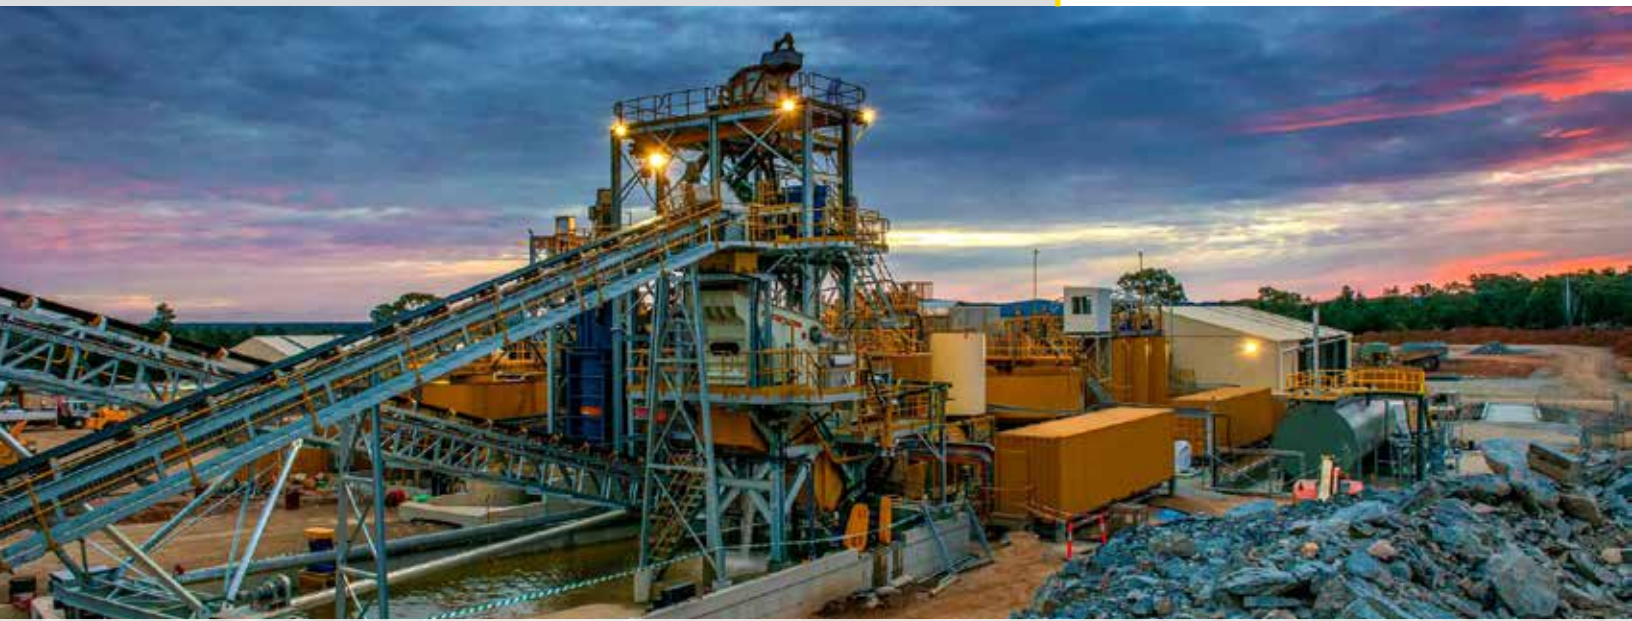
On a mobile feed chute, a rock box is normally used to prevent chute wear at the impact zone. The customer was using 3" thick liners welded on AR plate, with costly repairs and frequent change-outs. Severe damage could be observed in a very short period of time due to the extreme impact this part was subject to.

The Castolin Eutectic wear management team, working in close collaboration with the customer, analysed the wear mechanisms involved and the trajectory of the material affecting the part. With this information, Eutectic Services and the Technical team designed a custom rockbox chute liner to create a deadbed for ore-on-ore wear. For this application, the selected material was CastoChrome casting. With its metallurgical bond and composite structure, CastoChrome wear parts offer a complete made-to-perform component, providing exceptionally impact and abrasion-resistant wear liners with a safe and quick installation procedure.

The CastoChrome® rockbox was delivered on time and successfully installed. To this date, Castolin Eutectic's solution has helped increase part performance and service life drastically from 4 weeks to the scheduled maintenance cycle.
